# Manhole Inspection Summary

Manhole # S29M\_\_010MH

Record Plat: **29M** Node: **010** Status: **Other (Specify in comment)** Insp Date: **12/15/08 9:37 AM**

**Location** Address: **789 Scott St**

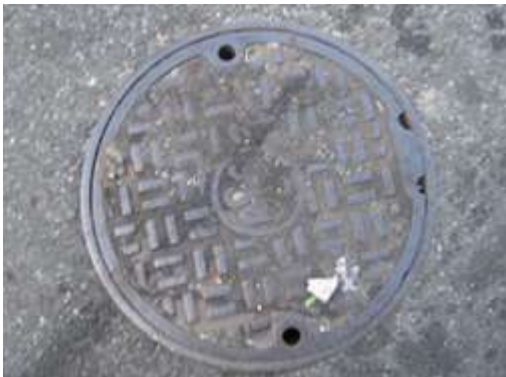
cover pic

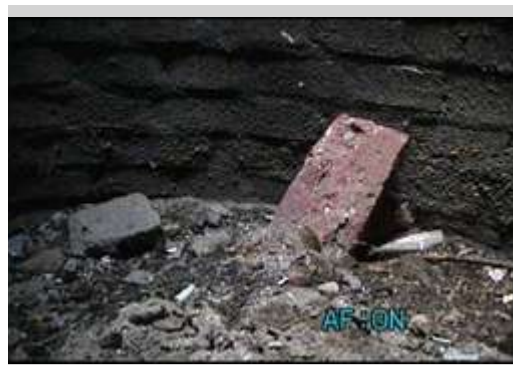
Defect 1

Condition: ☐ Sound ☐ Cracked ☐ Root Intrusion ☐ Deteriorated ☐ Leaks ☒ **Debris**

debris on bench and channel

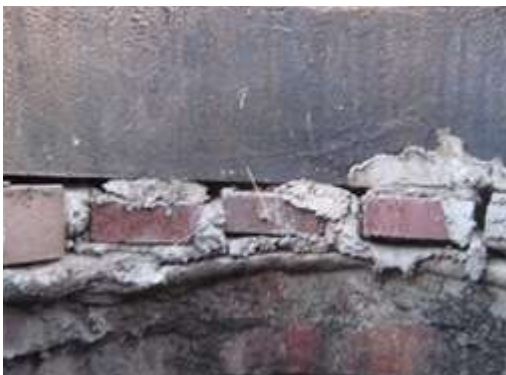
Defect 2

Condition: ☐ Sound ☐ Cracked ☐ Root Intrusion ☒ **Loose Brick** ☐ Deteriorated

missing mortar between chimney and frame.

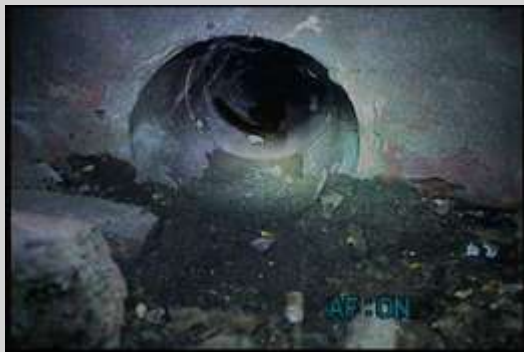
12 O'Clock Outflow

10 in. Circular Gravity Sewer  
Pipe Out @ 12 O'Clock
